# Joint Resealing Project at Fairchild Air Force Base, Washington

## Twenty-One-Year Field Performance

*Transportation Research Record: Journal of the Transportation Research Board*, No. 2361, Transportation Research Board of the National Academies, Washington, D.C., 2013, pp. 98–105.  
DOI: 10.3141/2361-12

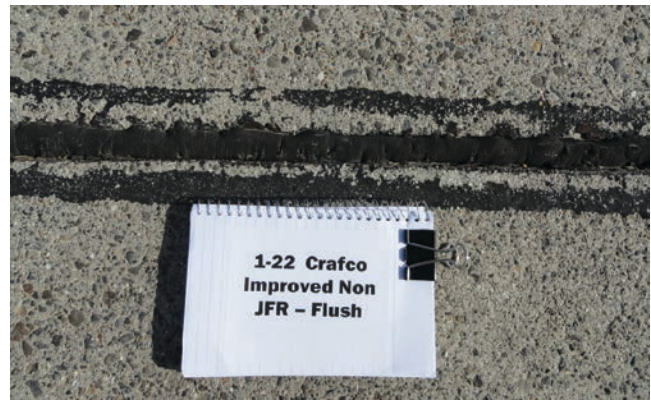
FIGURE 1 Sample of 21-year-old Crafco Improved Non-JFR sealant.

was full-depth adhesion loss at 49.0%. In flush-fill geometry, total failure was 13.0% at 250 months, with 3.1% spalling, 2.8% missing and damaged sealant, 9.4% full-depth adhesion loss, and 0.1% cohesive failure. Sealant life in the recessed configuration was estimated to be 13.8 years, and greater than 21 years for flush-fill geometry. Flush-fill geometry exhibited greater than a 52% increase in estimated sealant life versus recessed geometry. There was a significant amount of partial-depth adhesion failure in the sections, measuring up to approximately 12 mm (0.5 in.) deep. The primary mode of failure for this sealant was adhesion loss. In flush-filled sections, there were fewer partial-depth adhesion failures than in recessed sections. The sealant is showing improved performance compared with the standard FS-SS-S-1401C sealants installed on the project.

Field elongation at 250 months was 300% compared with 600% at 10 years, a 50% loss of elongation over the 11-year period. Laboratory test results show that the 21 years of field aging decreased the penetration from 12.7 mm to 7.5 mm (41%) and decreased resilience from 73% to 57% (22%). The sealant passed two cycles of the original 200% extension bond test at  $-29^{\circ}\text{C}$  ( $-20^{\circ}\text{F}$ ) and three cycles when tested at 100% extension at  $-29^{\circ}\text{C}$  ( $-20^{\circ}\text{F}$ ). Bond results indicate that the sealant had aged some and was not as extensible at low temperature as when originally installed, but it was still capable of high extension at low temperature. Flow testing at  $60^{\circ}\text{C}$  ( $140^{\circ}\text{F}$ ) showed the same 0.0 mm result as did the original sealant. The sealant softening point was  $96.1^{\circ}\text{C}$  ( $205^{\circ}\text{F}$ ), which meets ASTM D6690 requirements of an  $80^{\circ}\text{C}$  ( $176^{\circ}\text{F}$ ) minimum. Viscosity at the application temperature of  $204^{\circ}\text{C}$  ( $400^{\circ}\text{F}$ ) was 2,000 cp, which indicates easily pourable application characteristics. The sealant surface exhibited bubbling in both recess and flush-installation configurations. The sealant surface was aged and harder than the inside portions were. The sealant has remained elastic and resilient. The improved non-JFR specification developed during the project requires bond performance evaluation of 200% extension at  $-29^{\circ}\text{C}$  ( $-20^{\circ}\text{F}$ ), compared with the standard requirement of 50% at the same temperature, thus producing sealant with increased low temperature elongation properties. Sealants meeting the improved non-JFR specification are used by several state agencies in colder climates, and ASTM has incorporated this type of sealant into the D6690 Type IV specification. Figure 1 shows the 21-year-old sealant in the flush-fill installation.

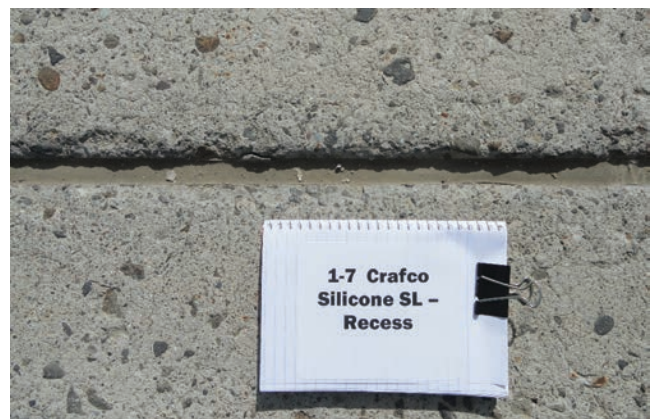
FIGURE 2 Sample of 21-year-old Crafco Silicone SL sealant.

This sealant exhibited 17.9% total failure at 250 months, compared with 16% at 10 years. There was 12.4% joint spalling, 3.0% missing sealant, 3.0% damaged sealant, 0.1% cohesion loss, and 4.2% full-depth adhesion loss. The 10-year data included the mechanically damaged sealant lengths. Adding back in the damaged lengths produces a failure amount at 250 months of 20.2% for best comparison to the 10 year results. Using total results, which includes spalling, sealant life is estimated to be greater than 21 years. The primary failure mode was spalling of the concrete joints, resulting in edge separations. Some partial-depth adhesion loss up to approximately 3 mm ( $\frac{1}{8}$  in.) deep was noted.

The field elongation testing result was 300% at 250 months, the same as at 10 years. The sealant did not experience loss of field elongation in the last 11 years. The sealant had a smooth surface and remains elastic and resilient. Laboratory test results in Table 8 show that the 21 years of field aging produced an elongation of 450%, a decrease of 45% from original results. Shore 00 hardness increased from 63 to 70. Results indicate that the sealant lost some extension during the first 10 years, and it has since retained similar extensibility over the last 11 years. The sealant remains flexible and extensible. Figure 2 shows a view of the 21-year-old sealant.

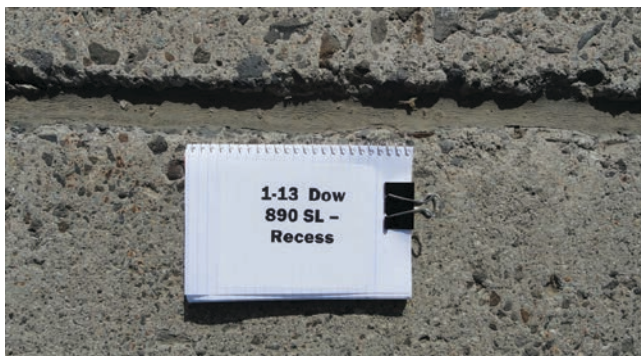
FIGURE 3 Sample of 21-year-old Dow Corning 890 SL sealant.

This sealant exhibited 34.5% total failure at 250 months, compared with 28% at 10 years. There was 13.8% joint spalling, 2.0% missing sealant, 0.4% damaged sealant, 1.9% cohesive failure, and 18.0% full-depth adhesion failure. Sealant life was previously reported to be 10 years. The main failure types were spalling and adhesion loss. A small amount of cohesive splitting occurred where the sealant was installed too thin. Partial-depth adhesion failures up to 3 mm ( $\frac{1}{8}$  in.) deep were present.

The field elongation test result was 600%, which is the same as the 10-year result, indicating that the sealant did not experience loss of elongation properties in the last 11 years. Laboratory test results for the 21-year-aged sealant showed elongation of 980% compared with the original 1,600%, a 43% decrease. Shore 00 hardness was 40 compared with the original reported 50, indicating some softening of the sealant. Results indicate that the sealant lost some elongation during the first 10 years, and it had retained similar extensibility over the last 11 years. The sealant had a wrinkled appearing surface and remained flexible and extensible. Figure 3 shows a view of the 21-year-old sealant.
