A JOINT EFFORT TO REPAIR A BUSY CALIFORNIA HIGHWAY INTERCHANGE

REPAIRING UNRAVELING JOINTS

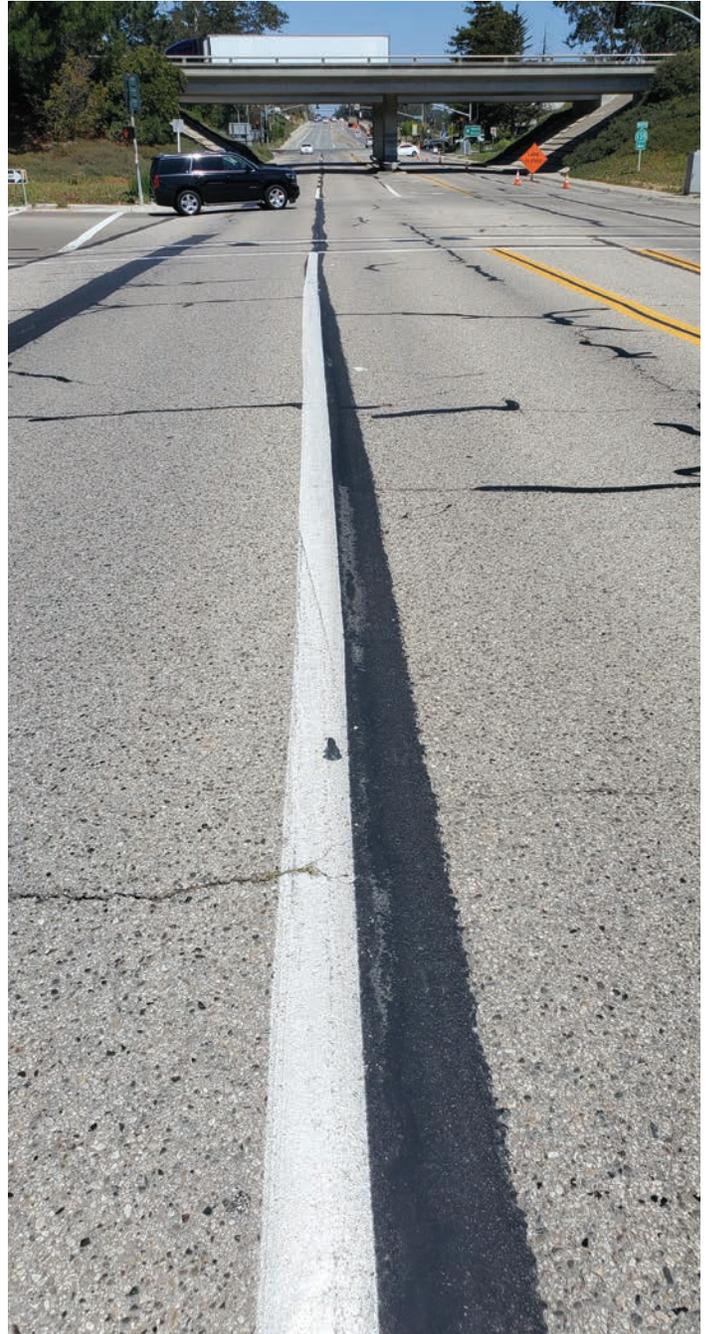
The crew applied 100 yards of the Mastic One material at a time with the drag box, saving the county countless hours.

Using the CrafcO Patcher II melter, the crew applied 100 yards of the Mastic One material at a time with the drag box. By milling out 100 yards of the material at a time, the crew

was able to save the county countless hours. The project was completed in two days with a crew of eight, versus HMA that requires a larger crew.

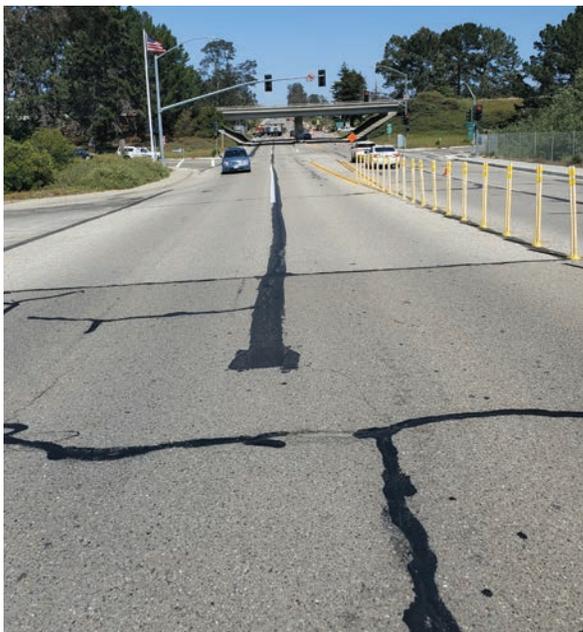
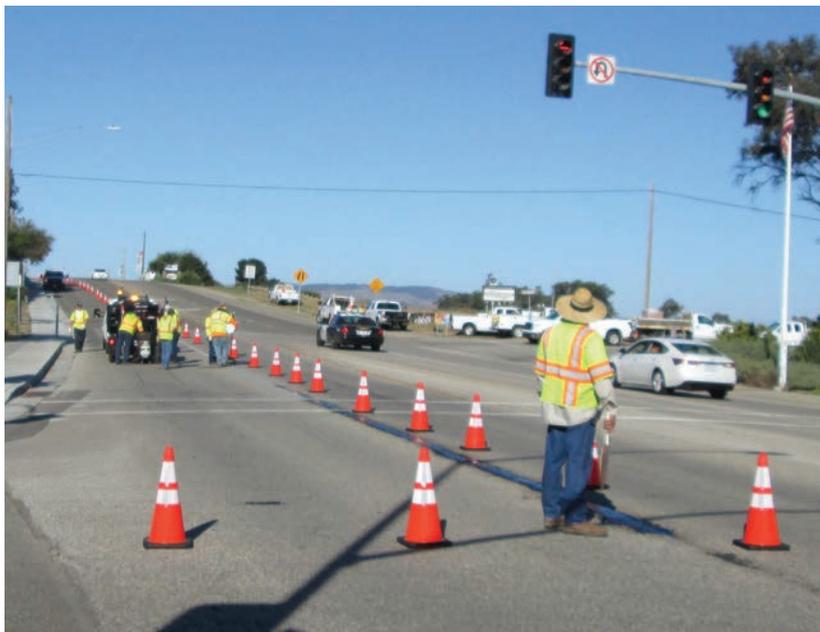
Mastic One cools quickly after installation and is ready for traffic when it has solidified sufficiently to support loads.

Because Mastic One cools quickly after installation and is ready for traffic when it has solidified sufficiently to support loads, the crew was able to complete the repairs quickly and minimize disruption to traffic flow. “Mastic One is traffic ready in less than an hour from application,” O’Brien says. “With a lot of heavy trucks using that intersection, the time we saved was really important.”
